NATIONAL OHS ALERT

PUSH PRO SERIES ELEVATED WORK PLATFORMS ALERT

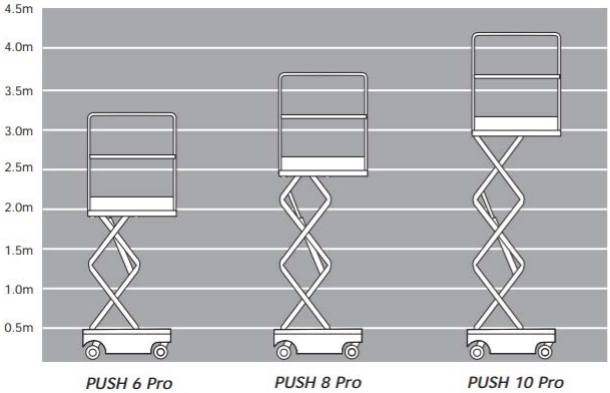
An incident has occurred in NSW where a horizontal force was applied to a Push 10 Pro EWP causing it to become unstable and tip over with a worker in the basket.

It has been concluded that the EWP is **not** fit for purpose

Push 10 Pro, Push 8 Pro and Push 6 Pro Elevated Work Platforms should not be used.
